Bio-inventory of 7704, 7780 and 7840 Superior Road, Lantzville, B.C.

Prepared for: Sincana Land Corp. C/o Darwin Mahlum 1 - 3179 Barons Road Nanaimo B.C. V9T 5W5 Prepared by: S.P. Toth, R.P.Bio. **Toth and Associates Environmental Services** 6821 Harwood Drive Lantzville, B.C. VOR 2H0

September 10, 2025

Riparian Areas Protection Regulation - Qualified Environmental Professional - Assessment Report

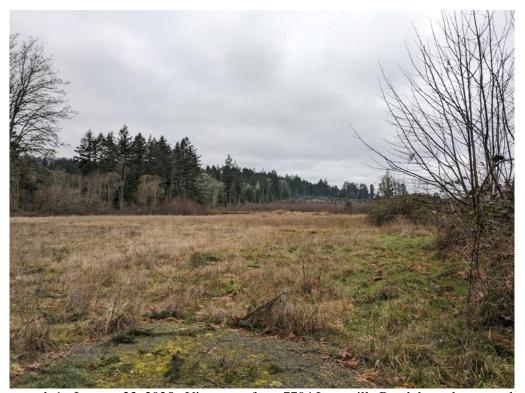
Photograph 1. January 23, 2025. View west from 7704 Lantzville Road through pasture lands

The pasture lands (Photograph 1) include a section of pasture in the south central portion of 7704 Superior Road and a small unused area of former pasture lands on the east side of 7780 Superior Road. The pasture is comprised of grasses and common weeds, fringed with Himalayan blackberry, Nootka rose and scotch broom. The unused pasture areas were reverting to forest lands and are comprised of grasses, sapling red alder, Himalayan blackberry, salmonberry, and wild gooseberry. Old drainage ditch networks were documented. Lack of ditch maintenance had resulted in flooding of pasture lands and expression of early successional stage wetland characteristics in some areas.

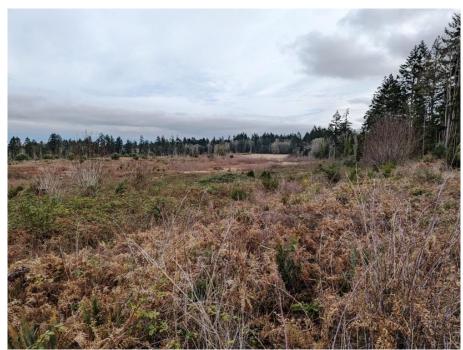
Photograph 2. January 23, 2025. View east from 7780 Lantzville Road through logged area to pasture lands.

Forest cover over the vast majority of the properties consists of approximately 7 year old regenerative forest typical of logged areas (Photographs 2 & 3). Tree cover is represented by seedling arbutus, Douglas-fir, and bigleaf maple suckers from stumps. The shrub layer is comprised of ocean spray, dull Oregon-grape, salal, trailing blackberry, thimble berry, Nootka rose, blackcap, common snowberry, and invasive spurge laurel, Himalayan blackberry, scotch broom, English ivy and English holly. The herb layer is comprised of sword fern, bracken fern, thistle, stinging nettle, common weeds and grasses.

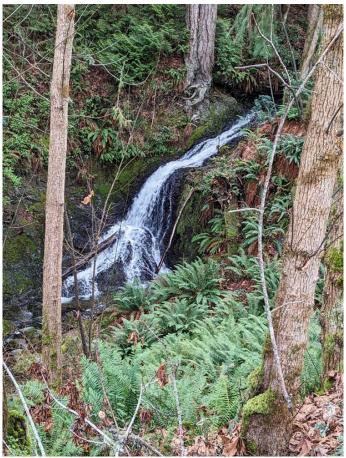
Photograph 4. January 23, 2025. View from top of ravine bank to falls on Knarston Creek.

The main water feature on the property is Knarston Creek located on the east side of 7704 Superior Road (Photographs 4 & 5). The RAPR Assessment conducted on Knarston Creek indicated that Knarston Creek would receive a Streamside Protection and Enhancement Area (SPEA) setback of 15.3 m from high-water-mark. The proposed watercourse setbacks are 15 m from top-of-ravine-bank, which will exceed the RAPR's SPEA setbacks on the west side of the ravine by approximately 0.24 ha.

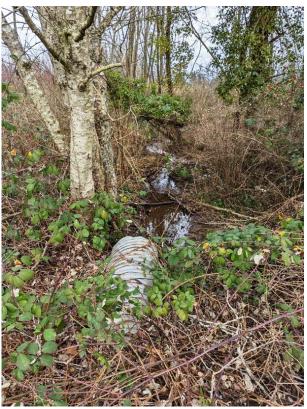
Photograph 6. January 23, 2025. View of culvert discharging ditch flows from Superior Road onto the subject property.

An unnamed tributary to Knarston Creek flows south – north through the west side of Lot 1. The tributary originates as drainage from an approximately 550 m long section of ditching and side street / driveway ditches along the south side of Superior Road that has been directed onto the subject property from a culvert at Superior Road (Photograph 6), as well as minor amounts of ditch drainage originating on the subject property. The ditch drainage has been directed to a shallow gully on the subject property. The channel within the gully downstream of the ditch network is poorly defined in some places. The gully section of the tributary would receive 10.0 m SPEA setbacks. The proposed stream buffer will exceed the SPEA setbacks at the north end near the E&N Railway.

At the upstream end of the gully the stream diverges into two old drainage ditches constructed to receive the drainage from the culvert at Superior Road and drain old pasture lands located between the south end of the gully and Superior Road. The ditches have not been maintained in many years, and as a result during the wet season the drainage from the Superior Road culvert spreads across the former pasture in undefined sheet flow.

A WSA Section 11 Notification authorization will be required for the proposed road crossing on the unnamed tributary. Engineered design including cross-sections and plan views, depth of fill and inlet / outlet armoring details will be required as part of the Notification submission. Minimum culvert sizing is 600 mm.

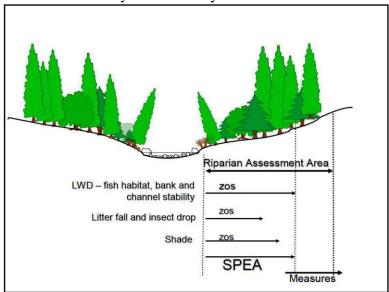
Zones of Sensitivity and how they relate to SPEA setbacks

The resulting SPEA setbacks vary from a minimum of 2 m to a maximum of 30 m depending on stream type, average channel width, channel gradient and potential vegetation type.
