ARCHAEOLOGICAL OVERVIEW ASSESSMENT

**Proposed Superior Road Development
Lantzville, BC**

March 20, 2019

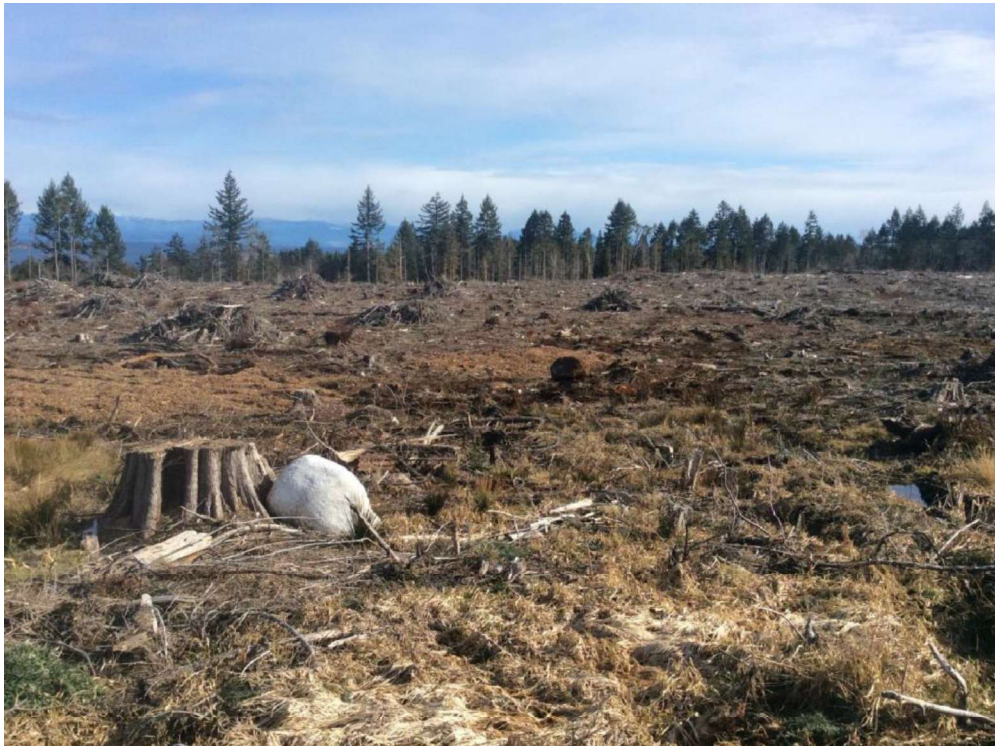
PHOTO 1: VIEW OF CLEARED PORTION OF THE PROJECT AREA

Looking east from the west access road. Note glacial erratic near the large stump in the foreground, standing water visible near the right side of the photo, and the generally softly undulating terrain.

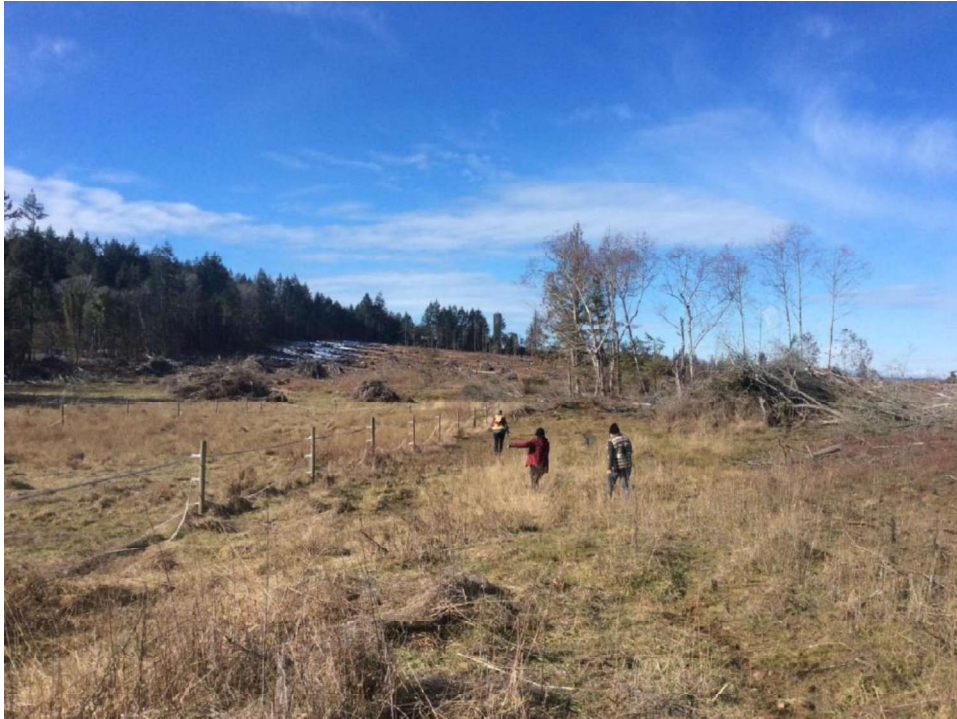
PHOTO 2: GRASSY PADDOCK AND FIELD (LEFT)

Looking west. Standing timber on right side of image is located on the banks of the unnamed drainage feature.

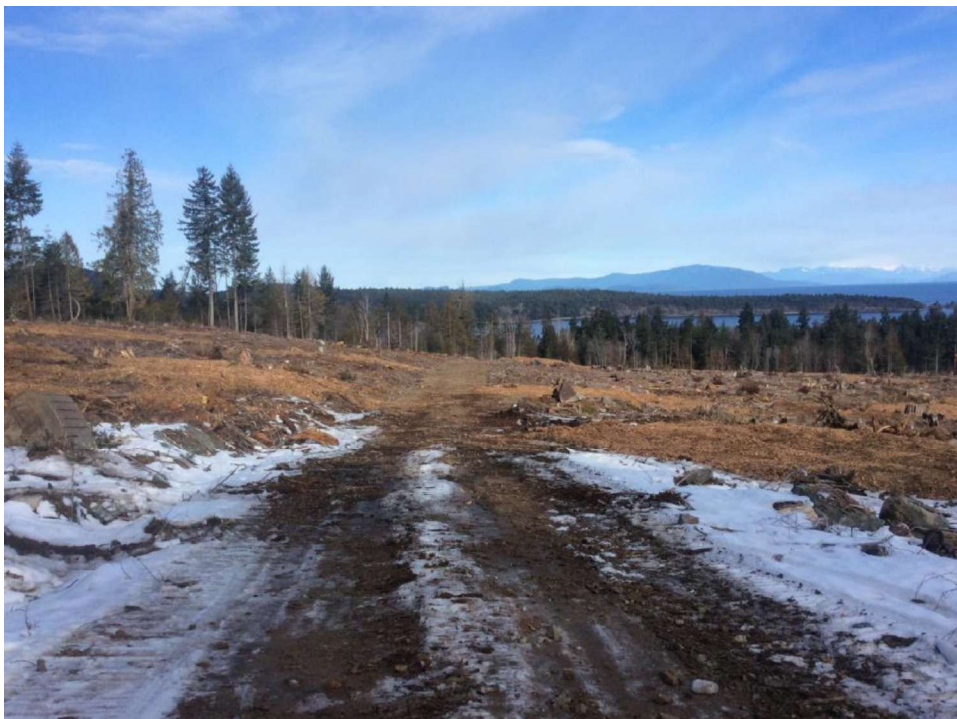
PHOTO 3: WEST ACCESS ROAD, LOOKING NORTH FROM SOUTH PROPERTY LINE.

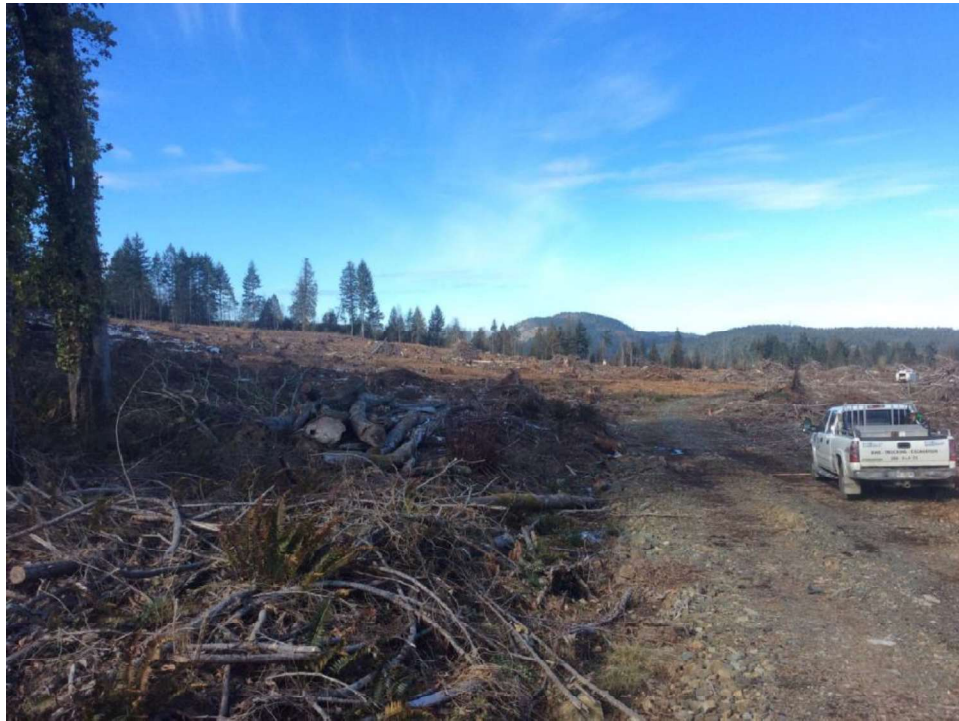
PHOTO 4: EAST ACCESS ROAD, LOOKING NORTH FROM SOUTH PROPERTY LINE.

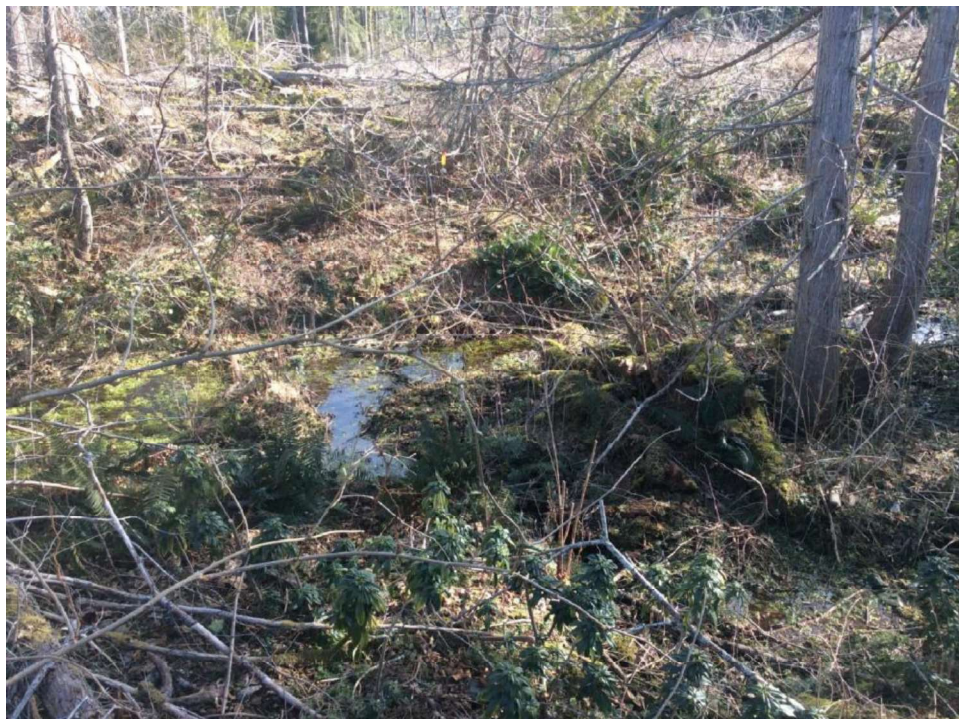
PHOTO 5: DRAINAGE FEATURE, LOOKING EAST FROM WEST BANK, SHOWING STANDING TIMBER AND GENTLY SLOPED BANKS.

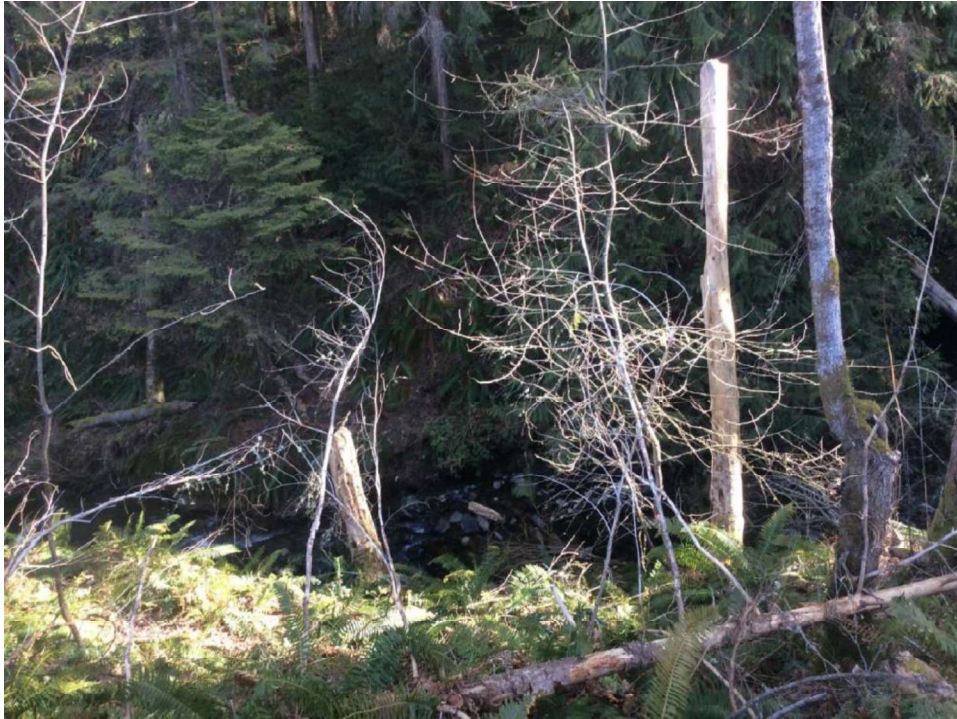
PHOTO 6: LOOKING EAST OVER KNARSTON CREEK FROM WEST BANK NEAR NORTH PROPERTY LINE.

Drop-off is roughly 10 m in this area.

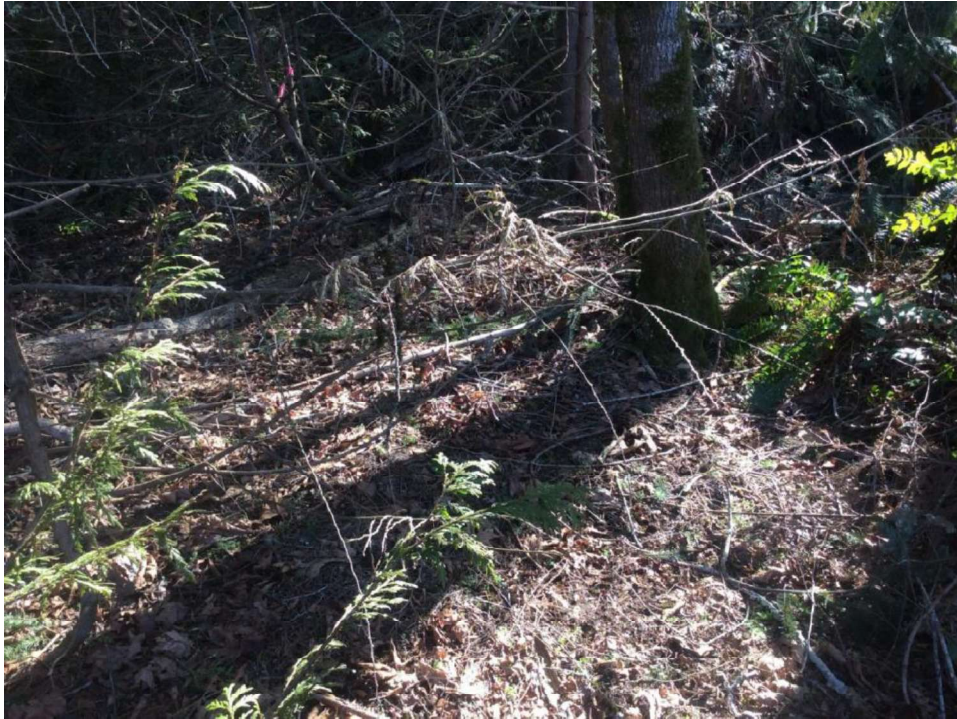
The property is generally devoid of terrain features associated with archaeological potential, with the exception of two areas of low to moderate archaeological potential on the west bank of Knarston creek (Figure 4). Both are level areas overlooking the creek with potential for lithic scatters representing temporary campsites. Area of Potential 1 measures roughly 10 m east-west by 5 m north-south (Photo 7), while Area of Potential 2 measures roughly 6 m east-west by 5 m north-south (Photo 8).

PHOTO 7: AREA OF POTENTIAL 1, LOOKING NORTH. THIS AREA IS FLAT, LEVEL, AND OVERLOOKS KNARSTON CREEK.

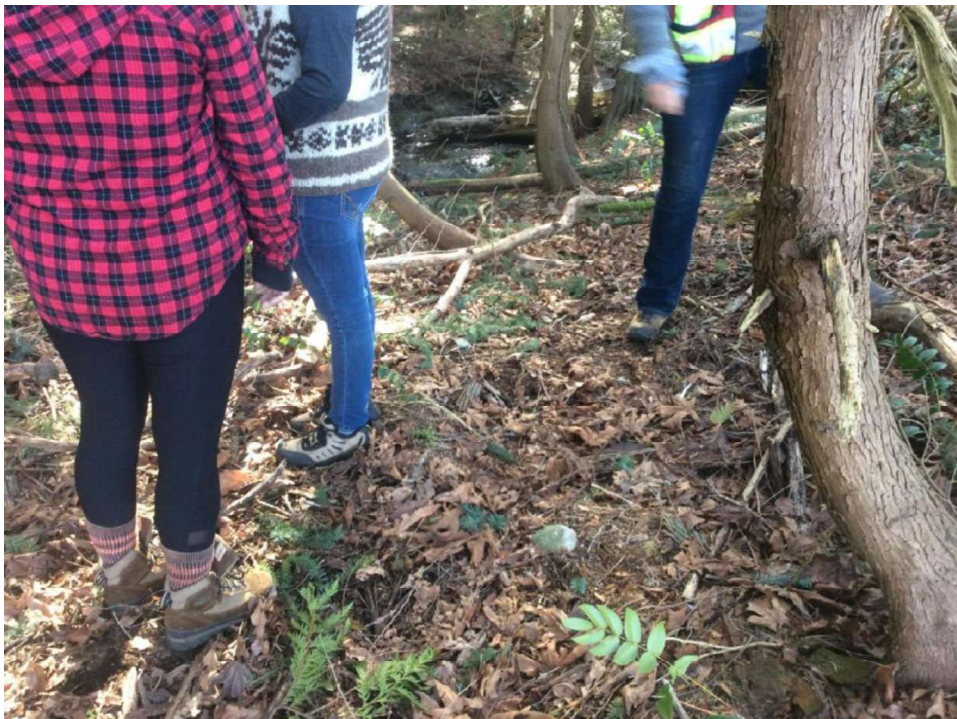
PHOTO 8: AREA OF POTENTIAL 2, LOOKING NORTH. THIS AREA IS SMALLER THAN AREA OF POTENTIAL 1, BUT THE ELEVATION OF THE BANK IS LOWER.

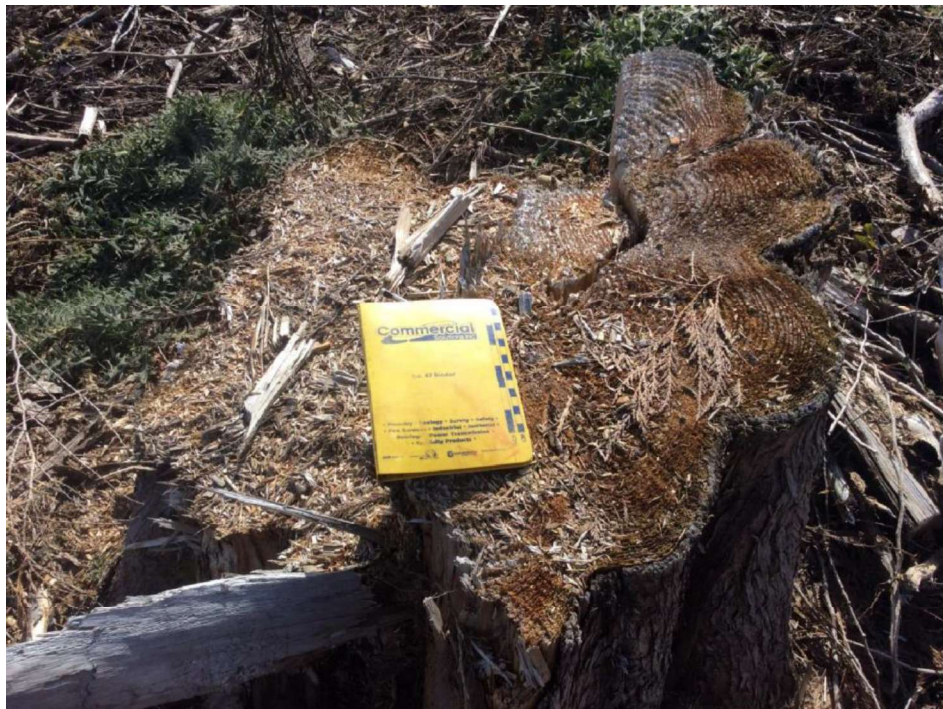
PHOTO 9: TYPICAL CEDAR STUMP IN RECENTLY CLEARED AREA.

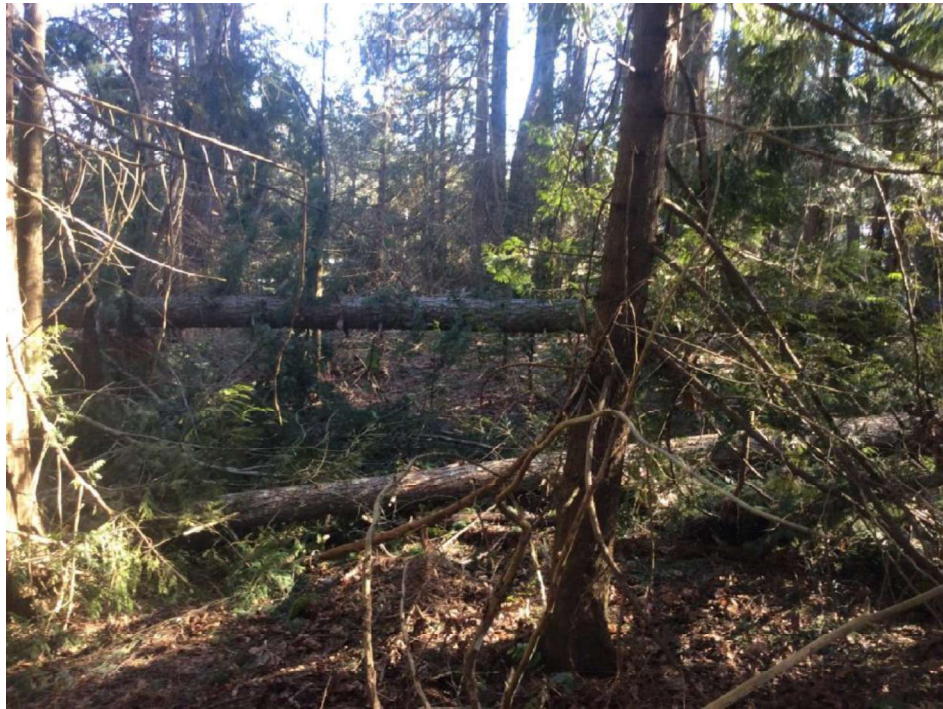
Observations of the remaining stumps in the cleared portions of the property indicate a mixed second growth forest of Maple, Douglas Fir, Western Red Cedar, and Arbutus. Stump diameter measurements ranged from 30-80 cm (Photo 9). No signs of cultural modification were observed on any tree stumps. The remaining standing timber surrounding Knarston Creek and the smaller drainage feature are consistent in size and species composition with the cleared areas. The understory east of Knarston creek is fairly open, consisting largely of mahonia and sword fern (Photo 10).

PHOTO 10: STANDING SECOND GROWTH FOREST EAST OF KNARSTON CREEK, SHOWING OPEN UNDERSTORY.

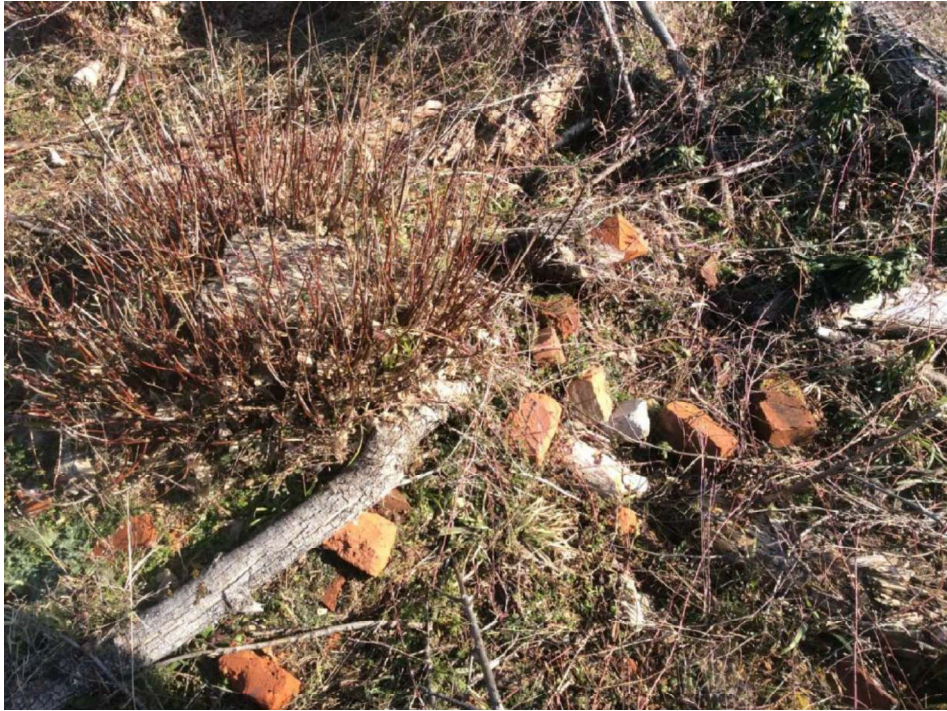
A pile of bricks was observed partially buried in the recently cleared northern third of Lot 3 (Photo 11). These may represent historic construction, as they appear to pre-date the associated stump.

PHOTO 11: PARTIALLY BURIED PILE OF BRICKS IN LOT 3.

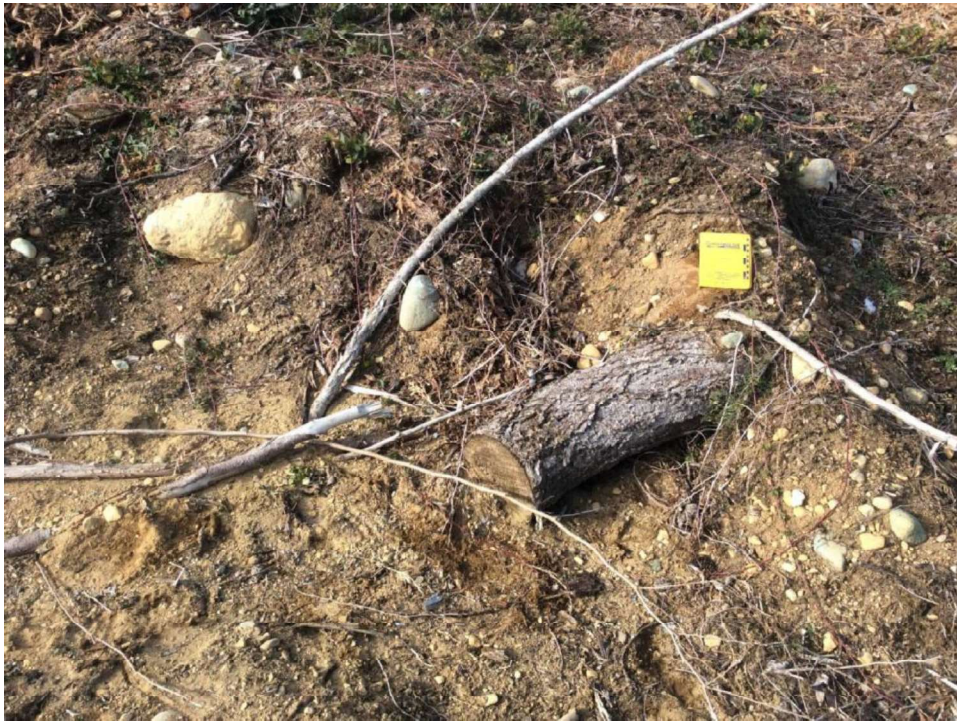
Observed exposures included road cuts, excavator tracks and shallow trenches, and tree throws. Soil development is poor, with a 2 cm layer of duff overlying light brown sands with 10% subrounded pebbles to a depth of 50 cm, which in turn overlies fine grey sand with slight clay content. Soil exposures in the west cut of the west logging access road (Photos 12 and 13) demonstrate this stratigraphic profile. Tree throws at the southwest corner of the paddock (Photo 14) and in the forested area east of Knarston Creek (Photo 15) show the same till deposits immediately underlying the thin duff layer. No shell midden or other cultural deposits were observed in any areas of the site.

PHOTO 12: WEST ROAD CUT OF WEST ACCESS ROAD, SHOWING THIN LAYER OF DUFF OVERLYING GLACIAL TILL.

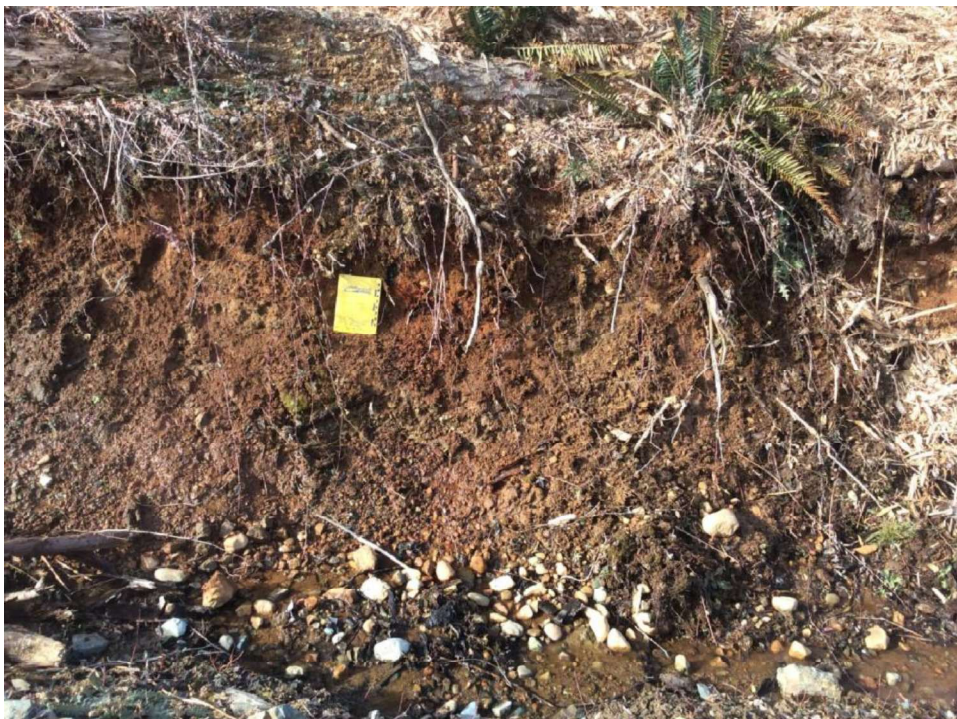
PHOTO 13: SECOND AREA OF ROAD CUT SHOWN IN PHOTO 12, SHOWING REDDER SAND WITH FEWER INCLUSIONS.

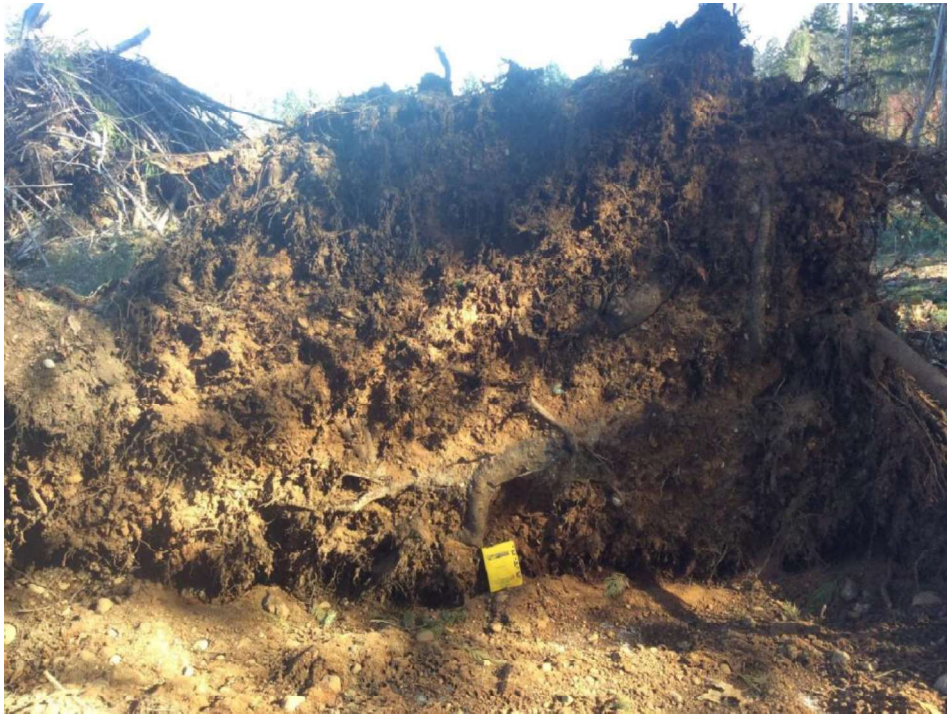
PHOTO 14: TREE THROW IN THE SOUTHWEST CORNER OF THE Paddock

Showing light brown/yellow glacial till immediately below the surface.

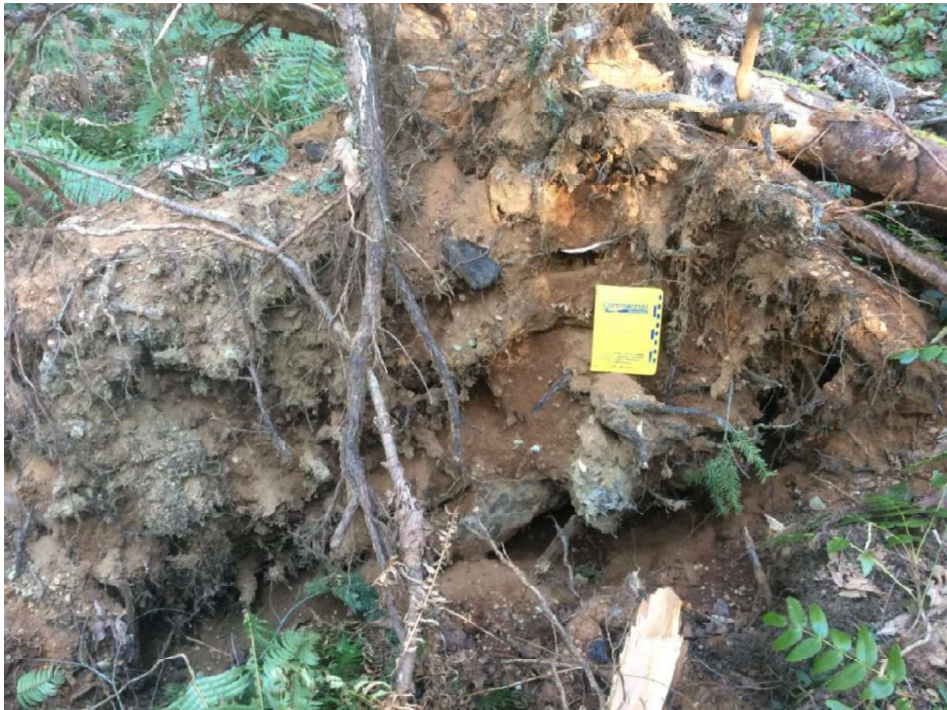
PHOTO 15: TREE THROW IN THE FORESTED AREA EAST OF KNARSTON CREEK

Demonstrating the continuity of till deposits on both sides of the creek.
